# HISTORIC RESOURCE SURVEY FOR THE BELLEFONTE NUCLEAR SITE IN JACKSON COUNTY, ALABAMA

# FINAL REPORT

Lead Agency: Nuclear Regulatory Commission

Tennessee Valley Authority West Tower 11D 400 West Summit Hill Drive Knoxville, Tennessee 37902

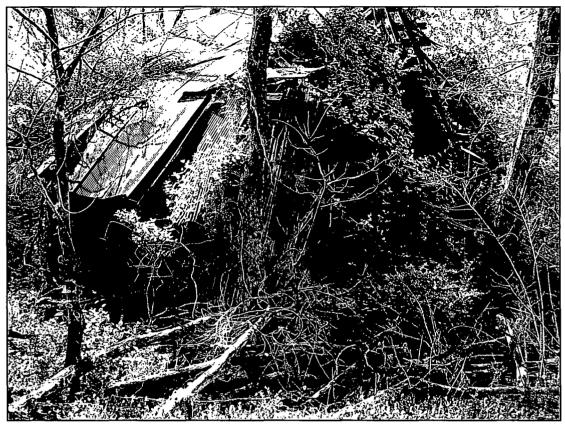
Figure 3. HR-1, façade and side elevation, facing southeast.

Due to the deteriorated state of the building, HR-1 does not retain the integrity of design, materials, or workmanship. The setting and feeling have been compromised by the demolition of the buildings associated with Bellefonte and the construction of surrounding modern structures. The building retains its integrity of location. Although the resource is associated with the history

of Bellefonte, because of the loss of integrity, the resource is no longer a good example of its type. In accordance with 36 CFR 60.4, the HR-1 tenant house is recommended ineligible for the NRHP under Criteria A and C., The resource is not associated with a person(s) significant on the national, state, or local level; thus, it is not eligible for the NRHP under Criterion B. Because of the factors discussed above, no further work is recommended for HS-1. The AHC has concurred with this recommendation.

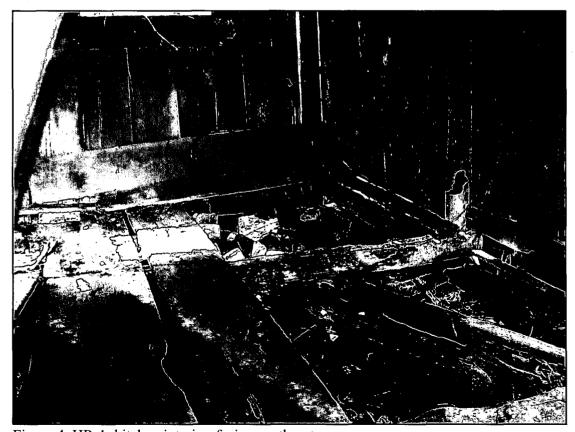
Figure 4. HR-1, kitchen interior, facing southeast.

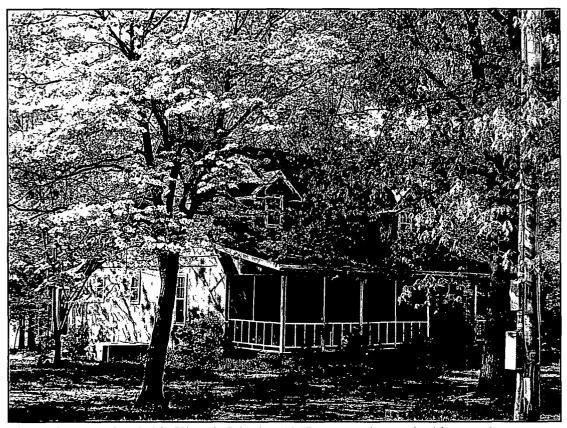
Figure 6. HR-2, Creekside Historic District, 1947 summer house, looking southeast.

HR-2 is historic district of summer homes located west of the project area along Town Creek. Constructed between 1947 and 1970, the dwellings are wood frame construction of vernacular and A-frame design (Jackson County Tax Assessor [JCTA] 2008). Typically clad with weatherboard or vertical wood planks, the fenestration varies from double-hung sash to fixed picture windows (Figures 5–7). The southernmost area is the oldest and the northernmost section of the district has modern construction dating from the 1980s and 1990s.

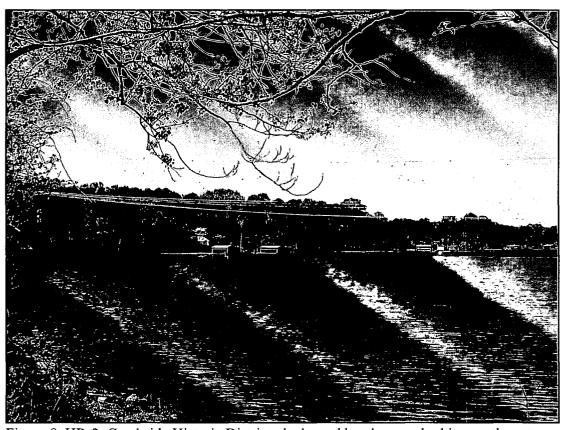
Figure 8. HR-2, Creekside Historic District, docks and boathouses, looking northwest.

Most of the summer homes have boathouses and docks which provide access to Town Creek (Figure 8). These structures as well as modern garages all date from the 1980s to present day.

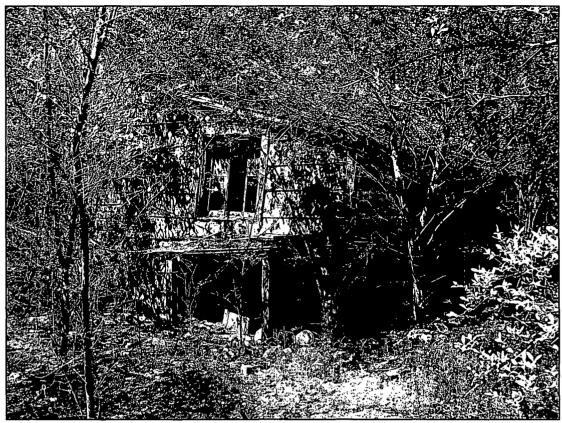
Figure 15. HR-4, rear addition, looking southwest.

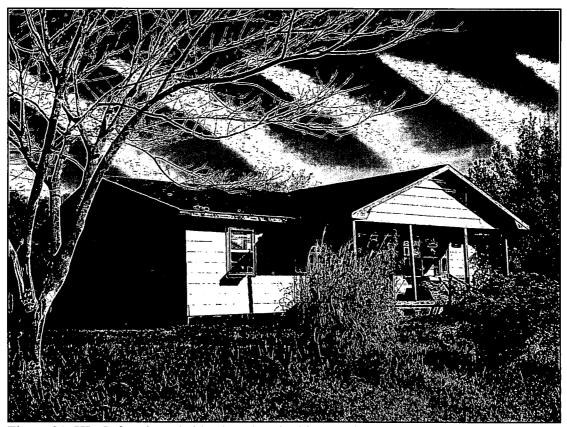
Set on a concrete block foundation, this one-story, five-bay vernacular dwelling is located west of the project corridor at 743 CR-113. Constructed in 1953, the dwelling is wood frame construction clad with asbestos siding (JCTA 2008). The side gable roof is covered with asphalt shingles and exhibits overhanging eaves. The fenestration is single and paired two-over-two, double-hung wood sash windows. The single-leaf entry is set within a front-gabled porch. The porch has wood posts and a concrete-block deck. There are no alterations or additions (Figure 21).

Figure 21. HR-5, façade and side elevation, looking northwest.

The building retains its integrity of location, design, materials, and workmanship. The setting and feeling have been compromised by the construction of surrounding modern structures including the Bellefonte Nuclear Site. Due to the unremarkable design, in accordance with 36 CFR 60.4, the HR-5 dwelling and tractor shed are recommended ineligible for the NRHP under Criterion C. The resource is not associated with an event or series of events, or with a person(s) significant on the national, state, or local level; thus, it is not eligible for the NRHP under Criteria A and B. For these reasons, no further work is recommended for HR-5. The AHC has concurred with this recommendation.

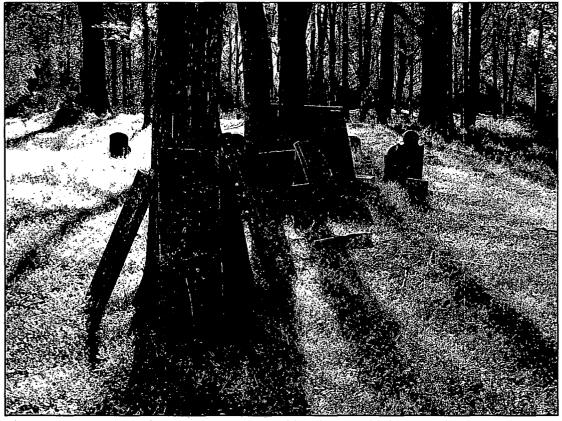
Figure 26. HR-8, Bellefonte Cemetery, moved headstones, looking northeast.

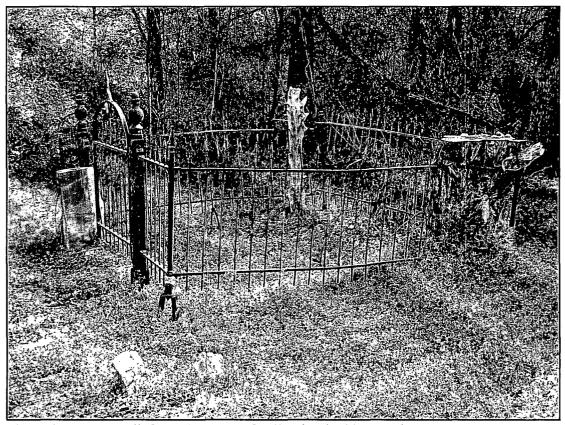
Figure 27. HR-8, Bellefonte Cemetery, family plot, looking north.

Listed on the Alabama Historic Cemetery Register in 2006, the Bellefonte Cemetery is located west of the project area on a hill on the north side of CR-33. Established in 1819, the cemetery site for the town of Bellefonte was chosen as the highest elevation within the town. The earliest inscribed marker is from 1819 and the last from 1936. In 1936, the TVA survey of the cemetery found 229 grave plots and 57 inscribed markers. The report stated that "the large number of unknown graves is due partly to the fact that the County 'hanging tree' is situated on the south line of the property. Local opinion is that a large number of burials resulted" (TVA 1936). The cemetery is accessed by a series of concrete steps that were added during the restoration of the cemetery in 2005. The stairs access the oldest section of the cemetery where many headstones and vault covers have been propped up against trees as the official location of the interments have been lost over time. Throughout the cemetery there are many interments that are unmarked or marked simply with limestone rocks as was the custom prior to 1850. Other types of markers include above-ground tombs, headstones and footstones, vault covers, and an obelisk (Figures 28–30). Marker designs that were observed were the Bible, hand with finger up, lambs, crown and cross, flowers, Woodmen of the World, and the Confederate States of America. There are three fenced family plots, one is unmarked, and the other two are for the Scruggs and Whisenant

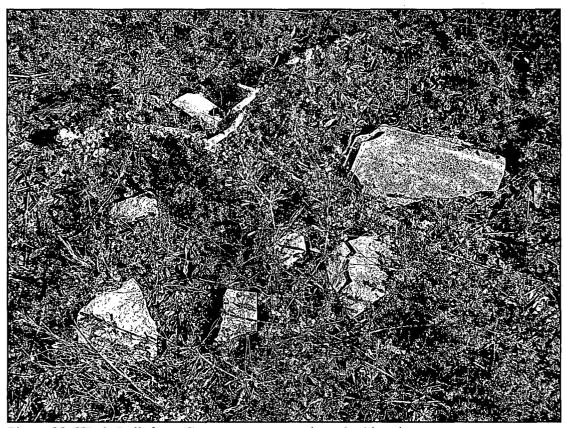
Figure 28. HR-8, Bellefonte Cemetery, stone markers, looking down.

Through neglect over time, many of the grave markers have been destroyed or lost, thus the resource does not retain the integrity of materials or design. The setting and feeling have been compromised by the demolition of the buildings associated with Bellefonte and the construction of surrounding modern structures (see Figure 2, sheet 1). The resource does retain the integrity of location and workmanship. In accordance with 36 CFR 60.4, HR-8 is recommended eligible for the NRHP under Criterion A for its association with the history of Bellefonte and Criterion B for the interments of the early settlers of the area. Due to the lack of integrity of design and materials the resource is not eligible under Criterion C. The Bellefonte Cemetery does meet Consideration D as it derives its primary significance from graves of persons important to the founding of Bellefonte and from its association with Bellefonte (National Park Service 1991:34). The NRHP boundary for this resource is the legal tax boundary, which includes the cemetery and surrounding woods (Figure 31). The setting of this resource has already been compromised by the existing modern construction of dwellings and the Bellefonte Nuclear Site (Figure 32). The proposed undertaking will not introduce significant new visual impacts. Therefore, it is TRC's opinion that the project will not pose an adverse effect to HR-8, and no further consideration of this resource is recommended in advance of the proposed undertaking. The AHC agrees with these findings.

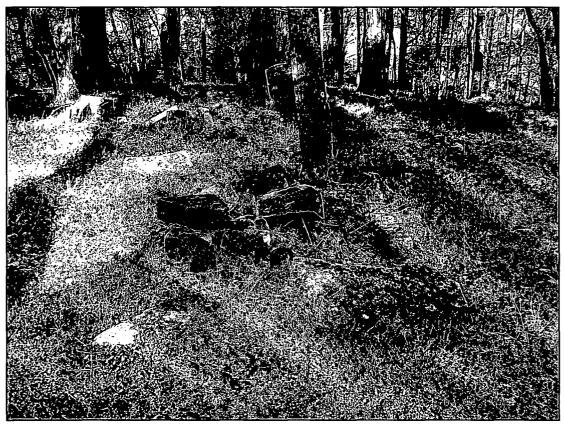
Figure 29. HR-8, Bellefonte Cemetery, broken above-ground tombs, looking west.

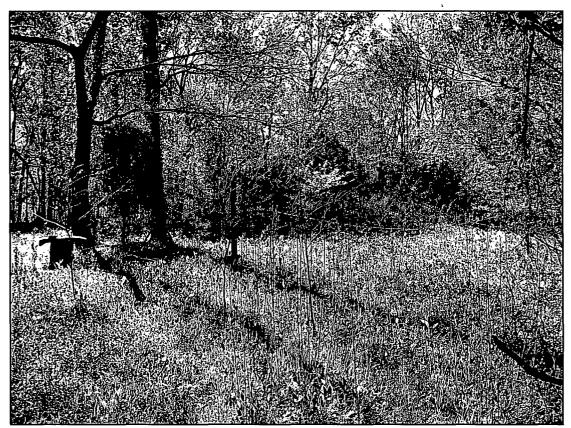
Figure 37. HR-10, Fennell-Hicks Cemetery, looking east.

The Fennell-Hicks Cemetery is located northeast of the project area off Bellefonte Road. Used as a family cemetery, the earliest marked interment is of Francis Fennell (1816–1872). The other marked graves are for his wife, Isabella Fennell (1814–1881), and Verena J. Hicks (1821–1882). The cemetery is fenced with wood posts and cables and there is one historic oak within the boundaries (Figure 37). The TVA acquisition maps from 1934 indicate that at least six graves are located within the cemetery (see Figure 2, sheet 2). Most of the headstones have been removed; those of Francis and Isabella (cracked in two) are propped against trees (Figure 38).

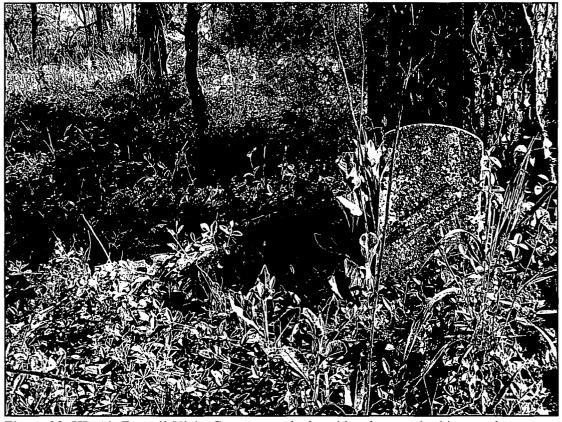
Figure 38. HR-10, Fennell-Hicks Cemetery, misplaced headstones, looking north.

Through neglect over time, many of the grave markers have been destroyed or lost, thus the resource does not retain the integrity of materials or design. The setting and feeling have been compromised by the demolition of the buildings associated with Bellefonte and the construction of surrounding modern structures. The resource does retain the integrity of location and workmanship. In accordance with 36 CFR 60.4, HR-10 is recommended ineligible for the NRHP. The resource is not associated with an event or series of events, or with a person(s) significant on the national, state, or local level; thus, it is not eligible for the NRHP under Criteria A and B. Due to the lack of integrity of design and materials the resource is not eligible under Criterion C. The Fennell-Hicks Cemetery does not meet Consideration D as it does not derives its primary significance from graves of persons of transcendent importance, from age, from distinctive design features, or from association with historic events (National Park Service 1991:34). For these reasons, no further work is recommended for HR-10. The AHC has agreed with this recommendation.

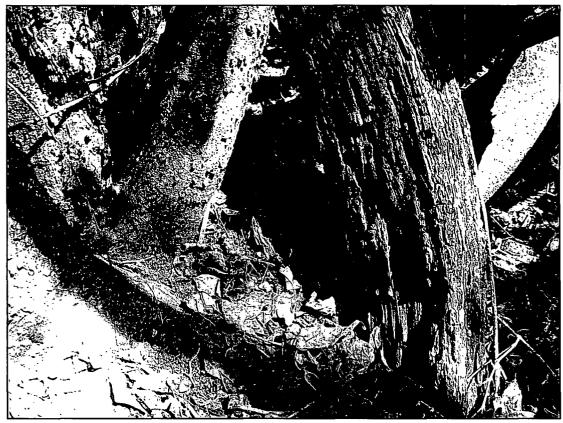
Figure 40. HR-12, section of cemetery in plowed field, looking east.

HR-12 is a cemetery located west of the project area in a plowed field. The cemetery was originally surveyed in 1934 as part of the Guntersville Dam project and it was noted as a private cemetery with approximately five graves (see Figure 2, sheet 1). The records of this survey can be found at the National Archives Southeast Region in Atlanta, Georgia. Located along the edge of a field, most of the stones have been destroyed by plowing. Some limestone markers remain in tree roots at the edge of a wooded area (Figures 40 and 41).

Through neglect and plowing over time, many of the grave markers have been destroyed or lost, thus the resource does not retain the integrity of materials, location, workmanship or design. The setting and feeling have been compromised by the demolition of the town of Bellefonte and the construction of surrounding modern structures. In accordance with 36 CFR 60.4, HR-12 is recommended ineligible for the NRHP. The resource is not associated with an event or series of events, or with a person(s) significant on the national, state, or local level; thus, it is not eligible for the NRHP under Criteria A and B. Due to the lack of integrity the resource is not eligible under Criterion C. The cemetery does not meet Consideration D as it does not derives its primary significance from graves of persons of transcendent importance, from age, from distinctive design features, or from association with historic events (National Park Service 1991:34). For these reasons, no further work is recommended for HR-12.

Figure 41. HR-12, section of cemetery in woods, looking west.

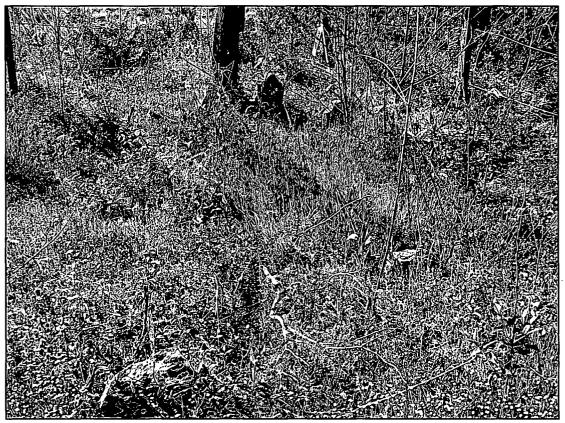
Figure 43. HR-13, Carter-Hansbrough Cemetery, looking northwest.

The Hansbrough-Carter Cemetery is located northwest of the project area on the west side of CR-113 in a field. It is just outside the 1-mile APE, but was recorded because it is in close proximity. Established ca. 1829, the cemetery was used for the burials of the Carter and Hansbrough families. The cemetery is marked off with wood posts and cables. A lintel carries a metal name plate which reads "Hansbrough Cemetery" (Figure 42) The TVA requisition map indicates that there are approximately 12 graves, some of which are unmarked (see Figure 2, sheet 1). The marked graves belong to some of the earliest residents of the area, Stephen Carter and his family, who married into the Hansbroughs. The graves are made of limestone and sandstone and the markers are headstones, footstones, and brick vault covers (Figures 43–44).
